ABOVEGROUND STORAGE TANK Steel Tank Institute (STI) SP001 External Tank Inspections MacDonald Oil Huntington, IN.

Service Provided By:
GENESIS ENVIRONMENTAL SOLUTIONS, INC.
8422 SOUTH 7 HIGHWAY
BLUE SPRINGS, MISSOURI 64014
OFFICE 816-229-5900 / FAX 816-229-4495

ABOVE GROUND STORAGE TANK (AST) INSPECTION

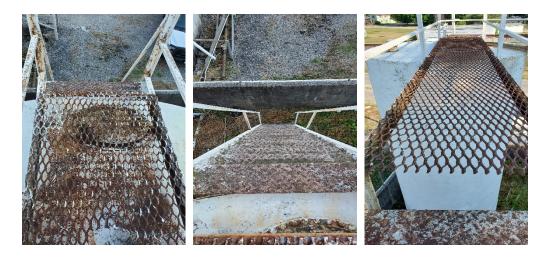
The ladders, platforms, and catwalks associated with these tanks was observed having coating failure. The ladders, catwalks, and platforms otherwise appeared to be in working condition.
